Revised **RESERVE STUDY**

The Jonathan Association

Chaska, Minnesota
Inspected - May 18, 2022
Revised - December 27, 2022

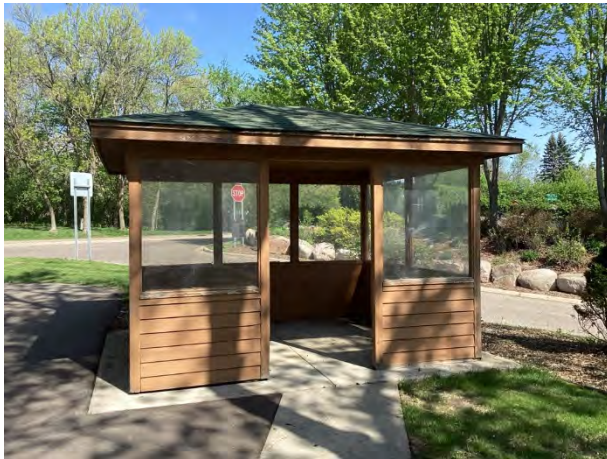
Condition: Good to fair overall with finish deterioration evident

Bus shelter at Neighborhood 1

Useful Life: Restoration of the bus shelters up to every 20 years including replacement of the roof and replacement of deteriorated siding and windows as needed.

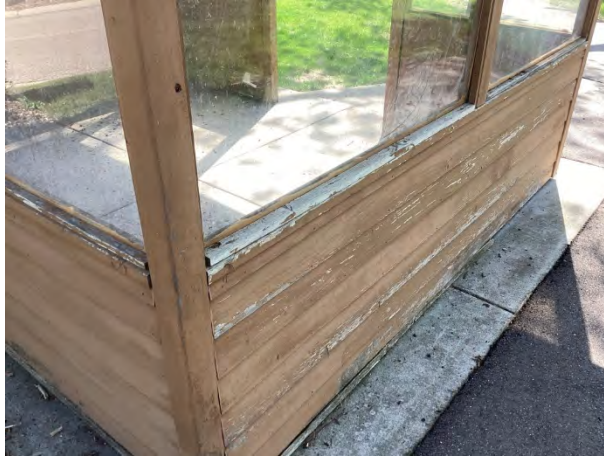
Finish deterioration at Bus shelter in Neighborhood 1

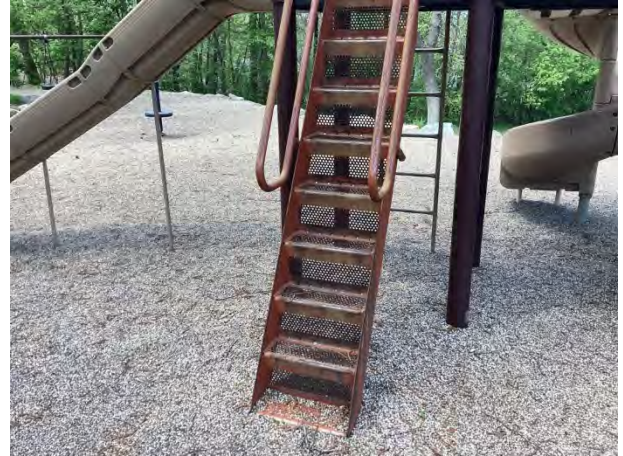
Equipment finish deterioration at playground equipment at Neighborhood 6

Useful Life: 15- to 25-years

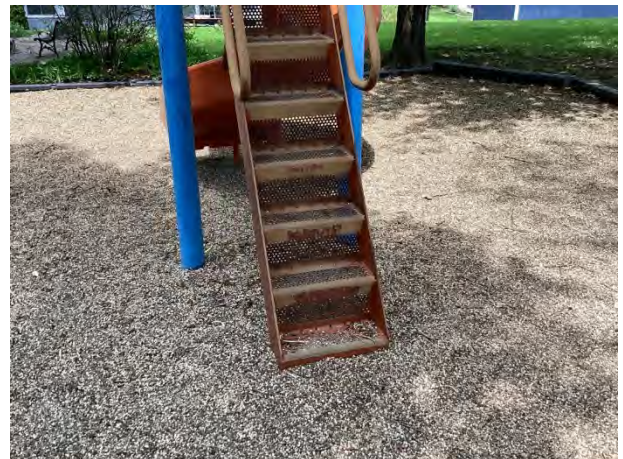
Equipment finish deterioration at Playground equipment at Neighborhood 9

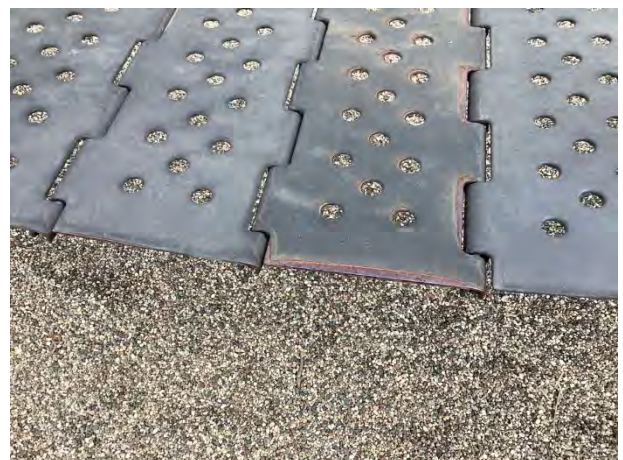
Equipment finish deterioration at playground equipment at Neighborhood 12

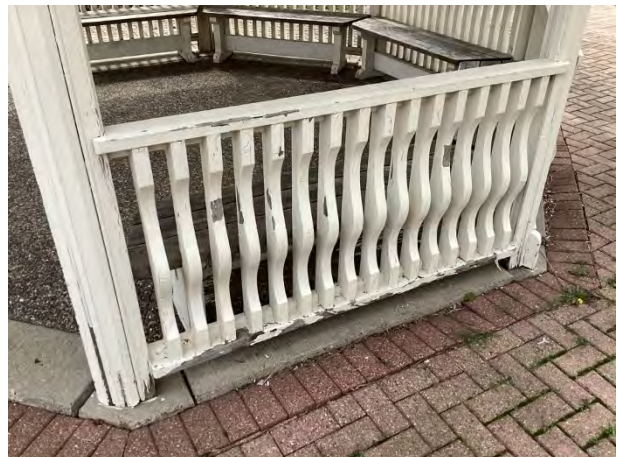
Condition: Good to fair overall with finish deterioration evident

Finish deterioration

Useful Life: Up to 25 years with periodic maintenance

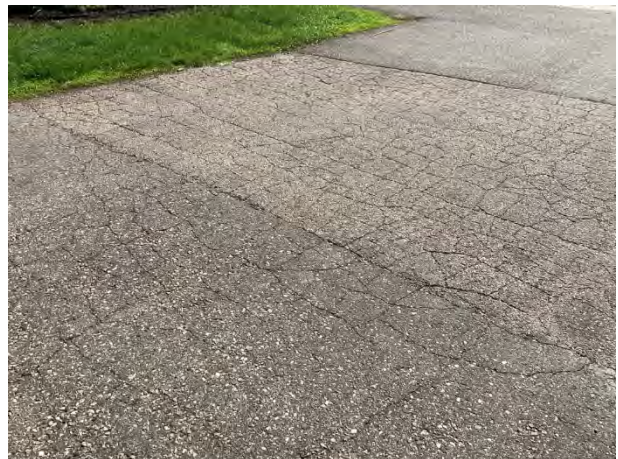
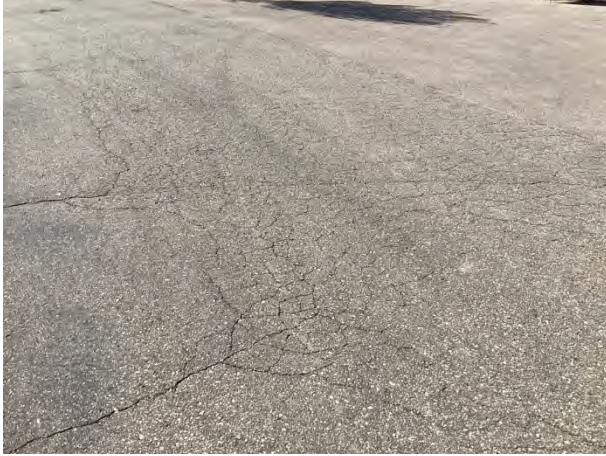
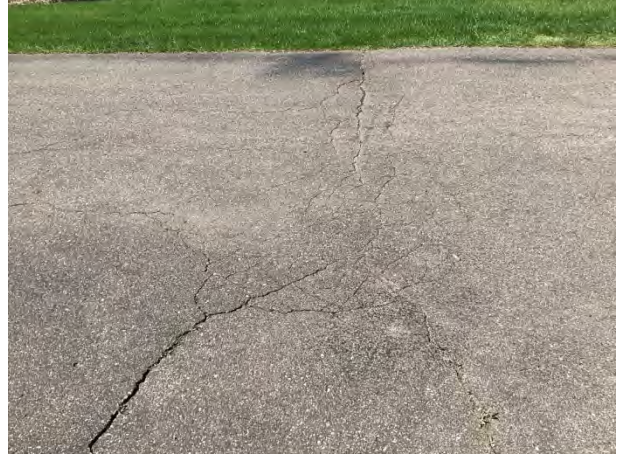
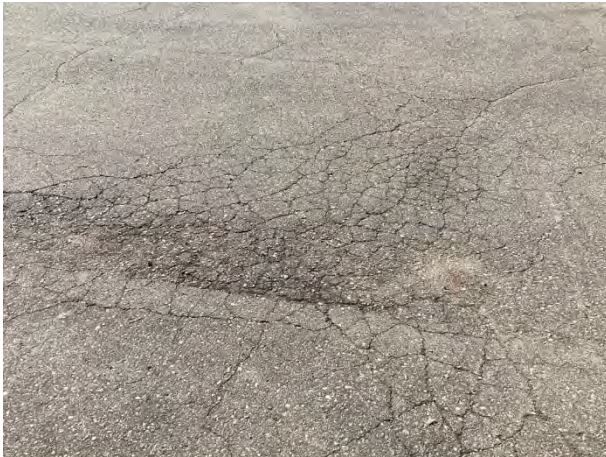
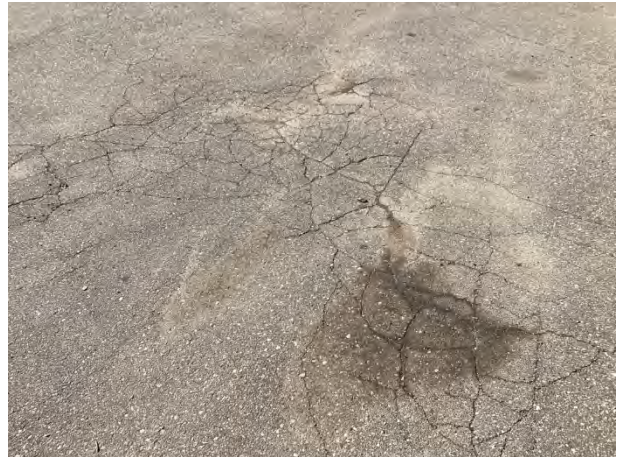
Condition: Good to fair overall with frequent cracks evident

Pavement cracks

Useful Life: 15- to 20-years with the benefit of timely crack repairs and patching

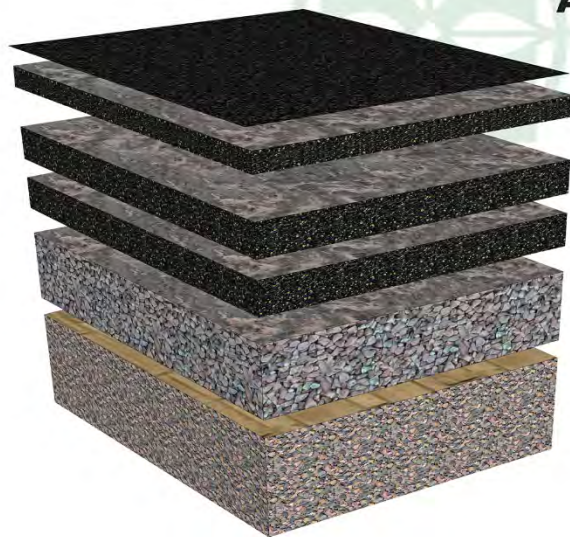
ASPHALT DIAGRAM

Component Detail Notes: The initial installation of asphalt uses at least two lifts, or two separate applications of asphalt, over the base course. The first lift is the binder course. The second lift is the wearing course. The wearing course comprises a finer aggregate for a smoother more watertight finish.

The following diagram depicts the typical components although it may not reflect the actual configuration at The Jonathan Association:

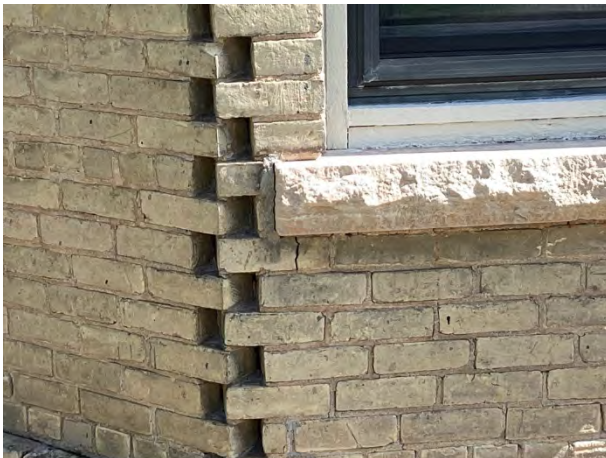
Condition: Conditions vary with masonry cracks and mortar deterioration evident.

Masonry cracks

Useful Life: Repairs and partial replacements every 10- to 15-years

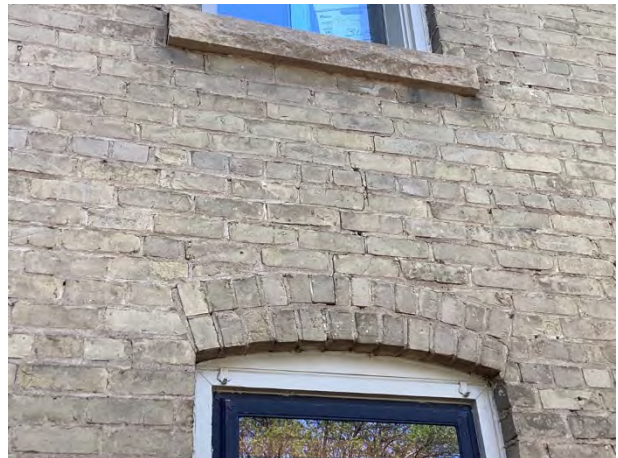
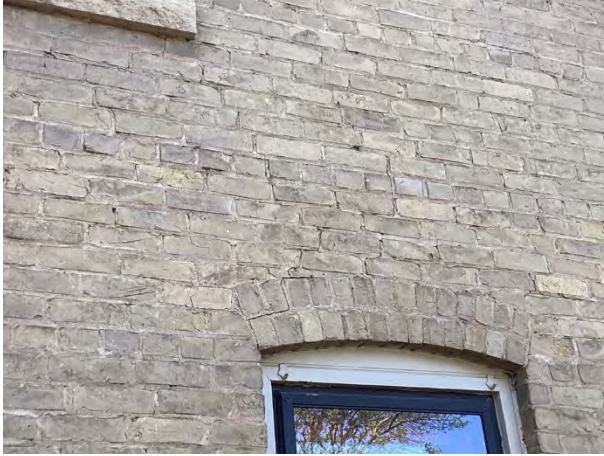
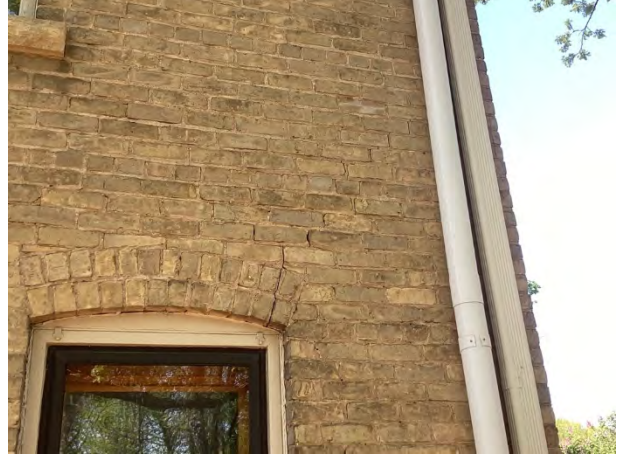
Masonry step cracks and mortar deterioration

Masonry step cracks

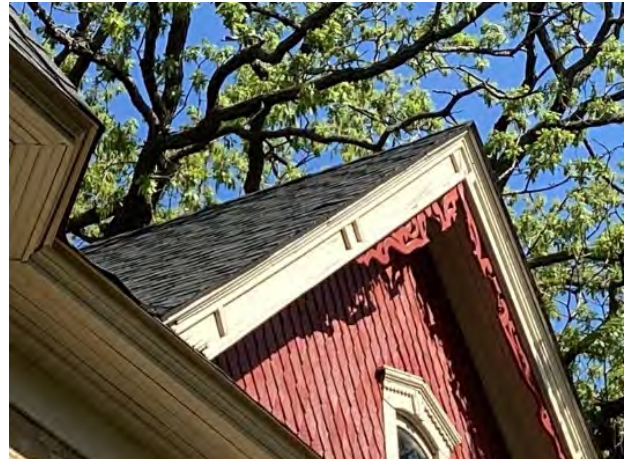
Condition: Good overall with isolated shingle lift evident from our visual inspection from the ground. Management and the Board do not report a history of leaks.

Shingle lift

Useful Life: 15- to 20-years

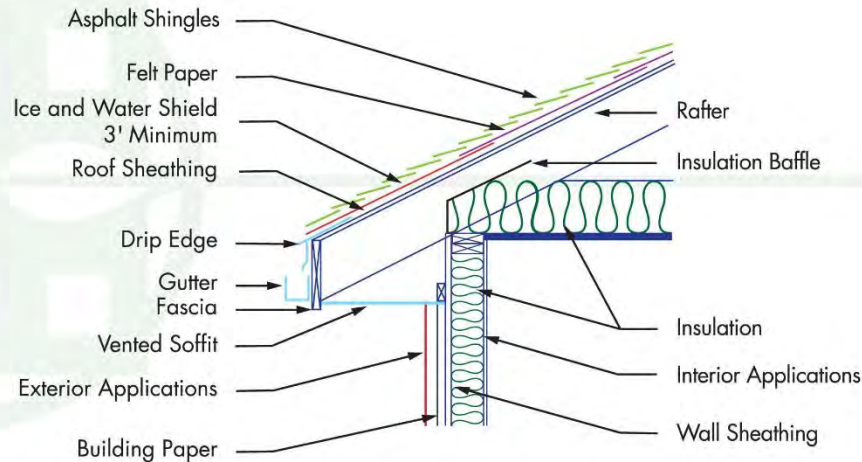
ROOF SCHEMATIC

Contractors use one of two methods for replacement of sloped roofs, either an overlayment or a tear-off. Overlayment is the application of new shingles over an existing roof. However, there are many disadvantages to overlayment including hidden defects of the underlying roof system, absorption of more heat resulting in accelerated deterioration of the new and old shingles, and an uneven visual appearance. Therefore, we recommend only the tear-off method of replacement. The tear-off method of replacement includes removal of the existing shingles, flashings if required and underlayments.

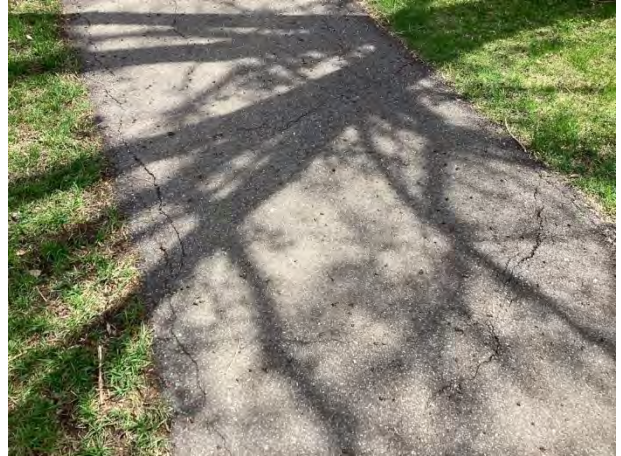
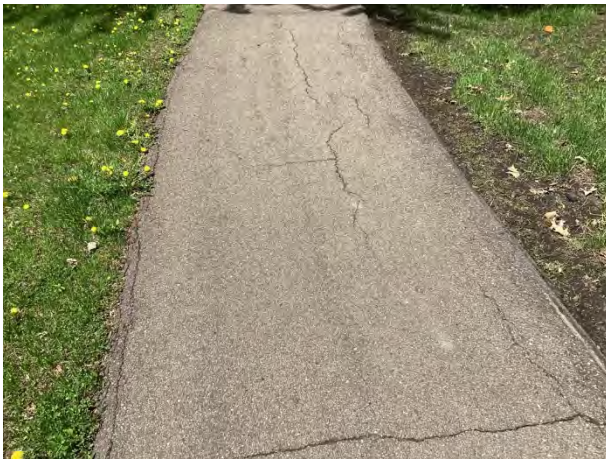
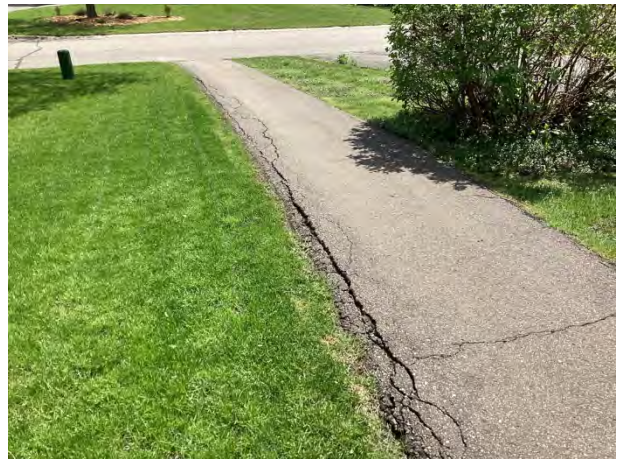
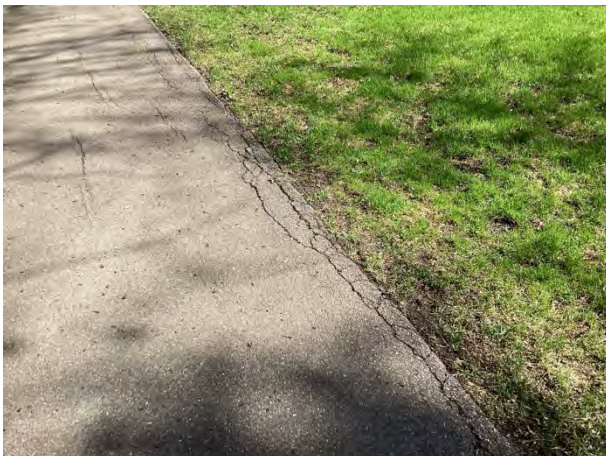
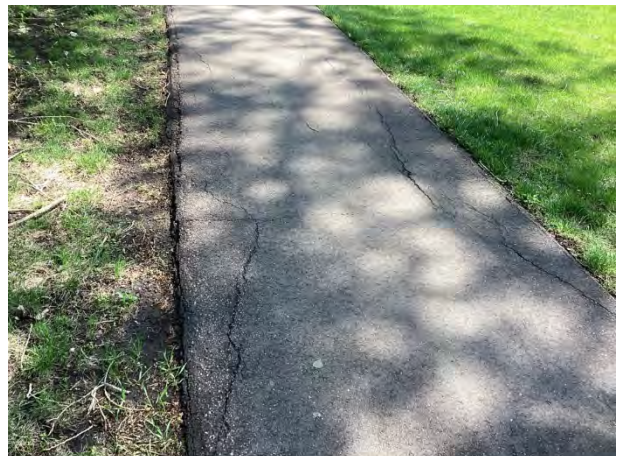
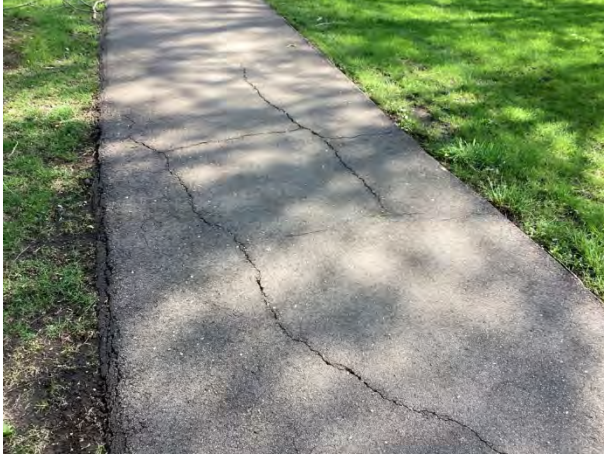
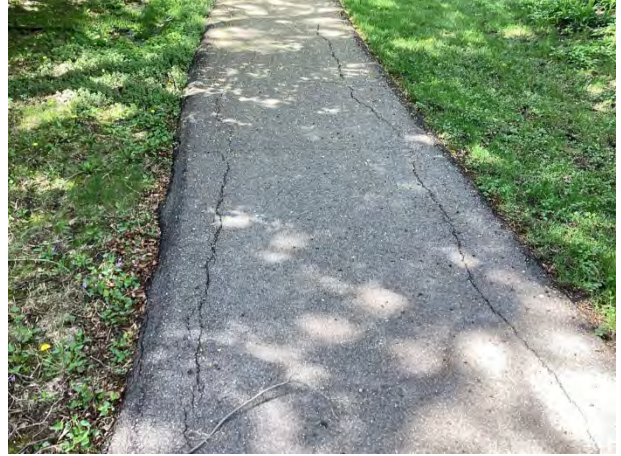
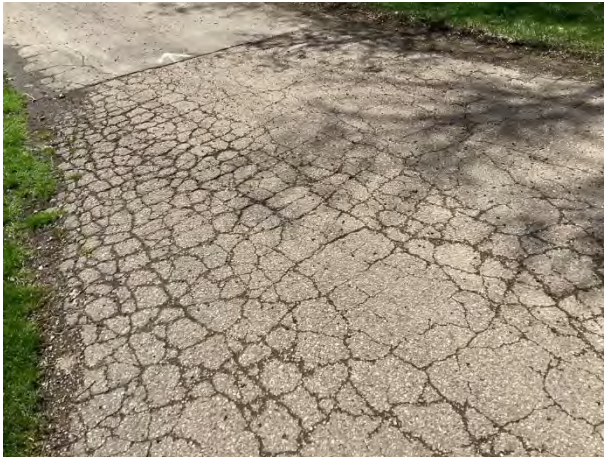
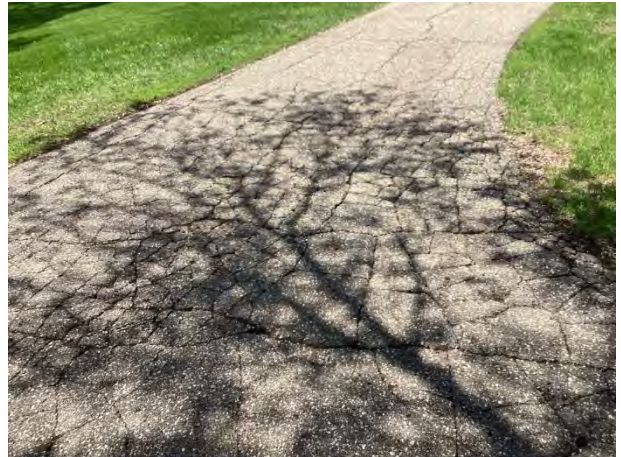
Condition: Various conditions ranging from good to poor overall with areas of significant cracks evident.

Walking path cracks

Useful Life: 10- to 15-years with the benefit of timely crack repairs and patching, and the need to maintain a safe pedestrian surface

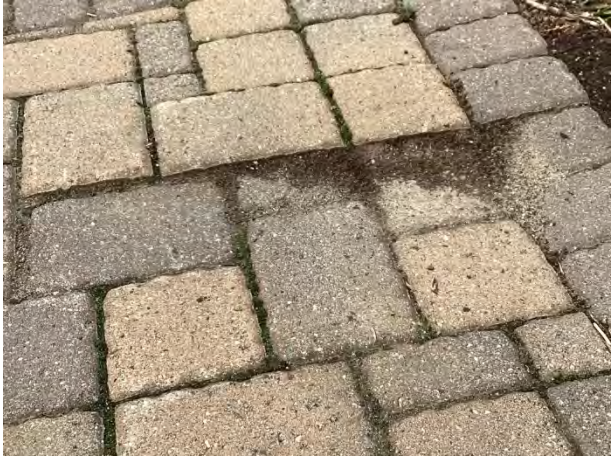
Condition: Good to fair overall with settlement, trip hazards and cracks evident

Paver trip hazards

Useful Life: 15- to 20-years

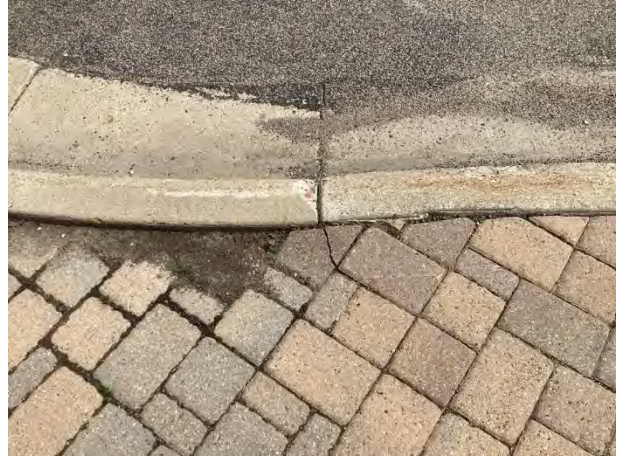
Paver settlement and cracks

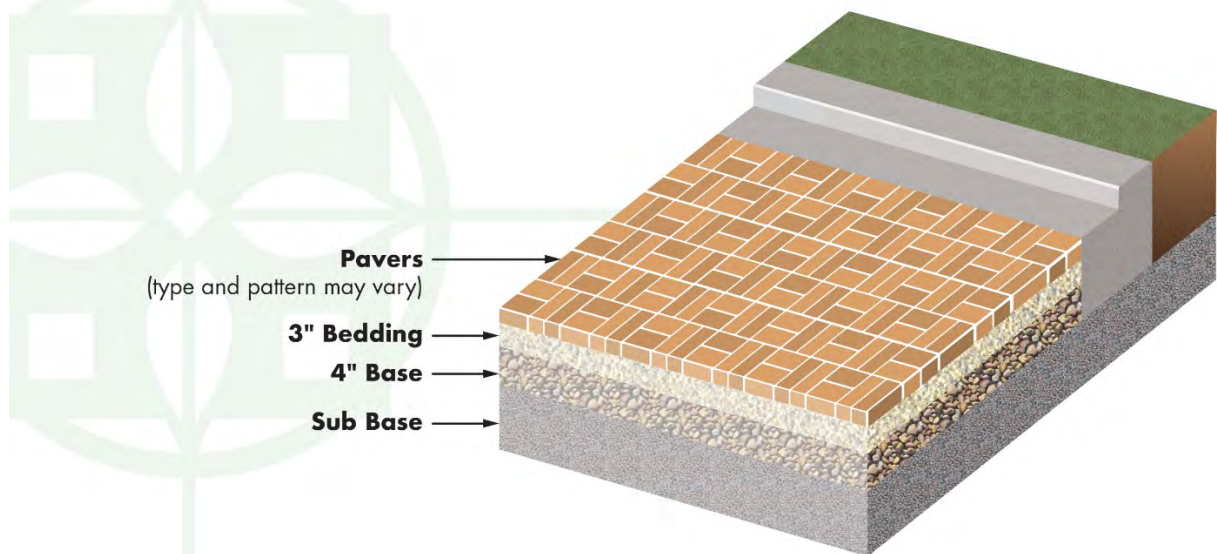
MASONRY PAVER DIAGRAM

Component Detail Notes: The following diagram depicts the typical components of a masonry paver system although it may not reflect the actual configuration at The Jonathan Association:

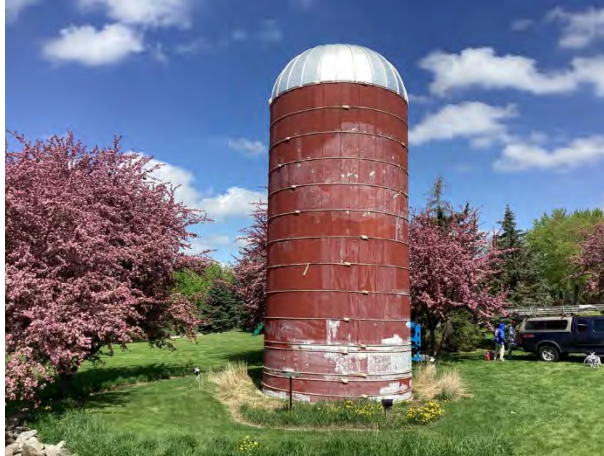
History: The Association had already funded and was in the process of painting the silo during our inspection

Silo overview; Note finish deterioration

Useful Life: Paint finish applications every five- to seven-years

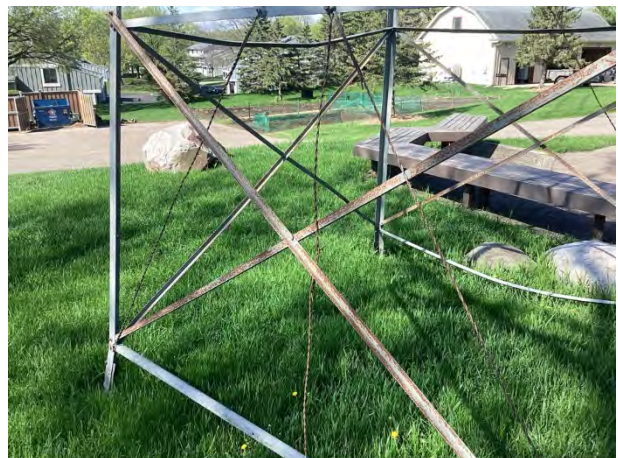
Condition: Good to fair overall with frame damage evident

Windmill frame damage

Useful Life: Inspections and capital repairs every 15- to 20-years

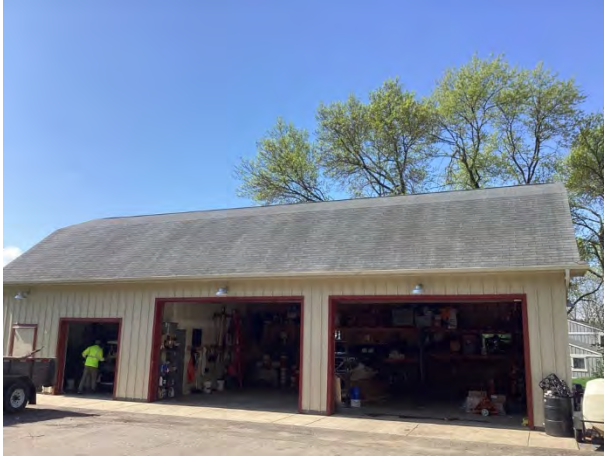
Condition: Good to fair overall with minor shingle lift evident and Management and the Board do not report a history of leaks.

Storage facility asphalt shingle roof overview
